# NEWSFLASH

RGWILBREY (CONSULTANTS) LIMITED

## STRIMMERS

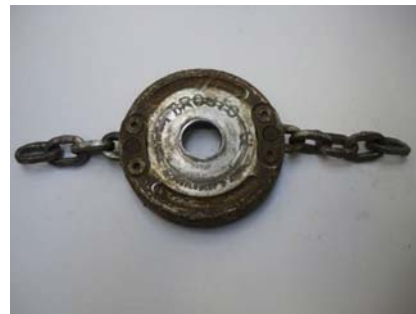
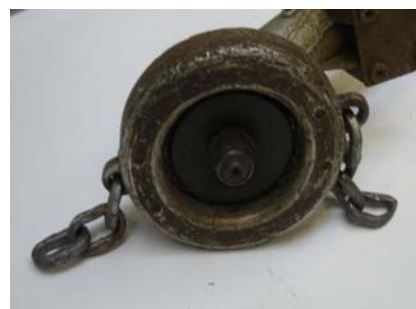
The safety alert arises from a fatal incident. Initial investigations indicate that a link from a **Non-standard** chain flail attached to a **Strimmer**, struck a nearby worker in the head

The high output shaft speed of a **Strimmer** creates the potential for significant energy to be transferred to the cutter head. When using **non standard parts** the risk from breakage and ejection of chain components at high speed is significant.

The use of non-standard cutting attachments not approved by the manufacturer may, because of their geometry and mass, induce excessive stresses which could result in premature failure and possible break-up of the **Strimmer**, thereby increasing the risk of injury from any ejected component.

Manufacturers' original cutting equipment such as nylon cords, metal cutting blades and saw blades are designed to be used in combination with specifically designed safeguarding systems. The chain flail attachments are not supplied with any compatible safeguard/deflector.

Any **Strimmer** fitted with chain flail or similar non-standard attachments should be taken out of service immediately and the attachments removed and replaced with the manufacturer's approved accessory.

Manufacturers' advice should be followed as to the appropriate combinations of cutting tools and guards.
